Section 2

The Existing Quarry

This section presents an overview of the existing Quarry including a description of the operations undertaken, a summary of monitoring results, together with an assessment of compliance with the current consents and licences and the applicable environmental criteria and guidelines.

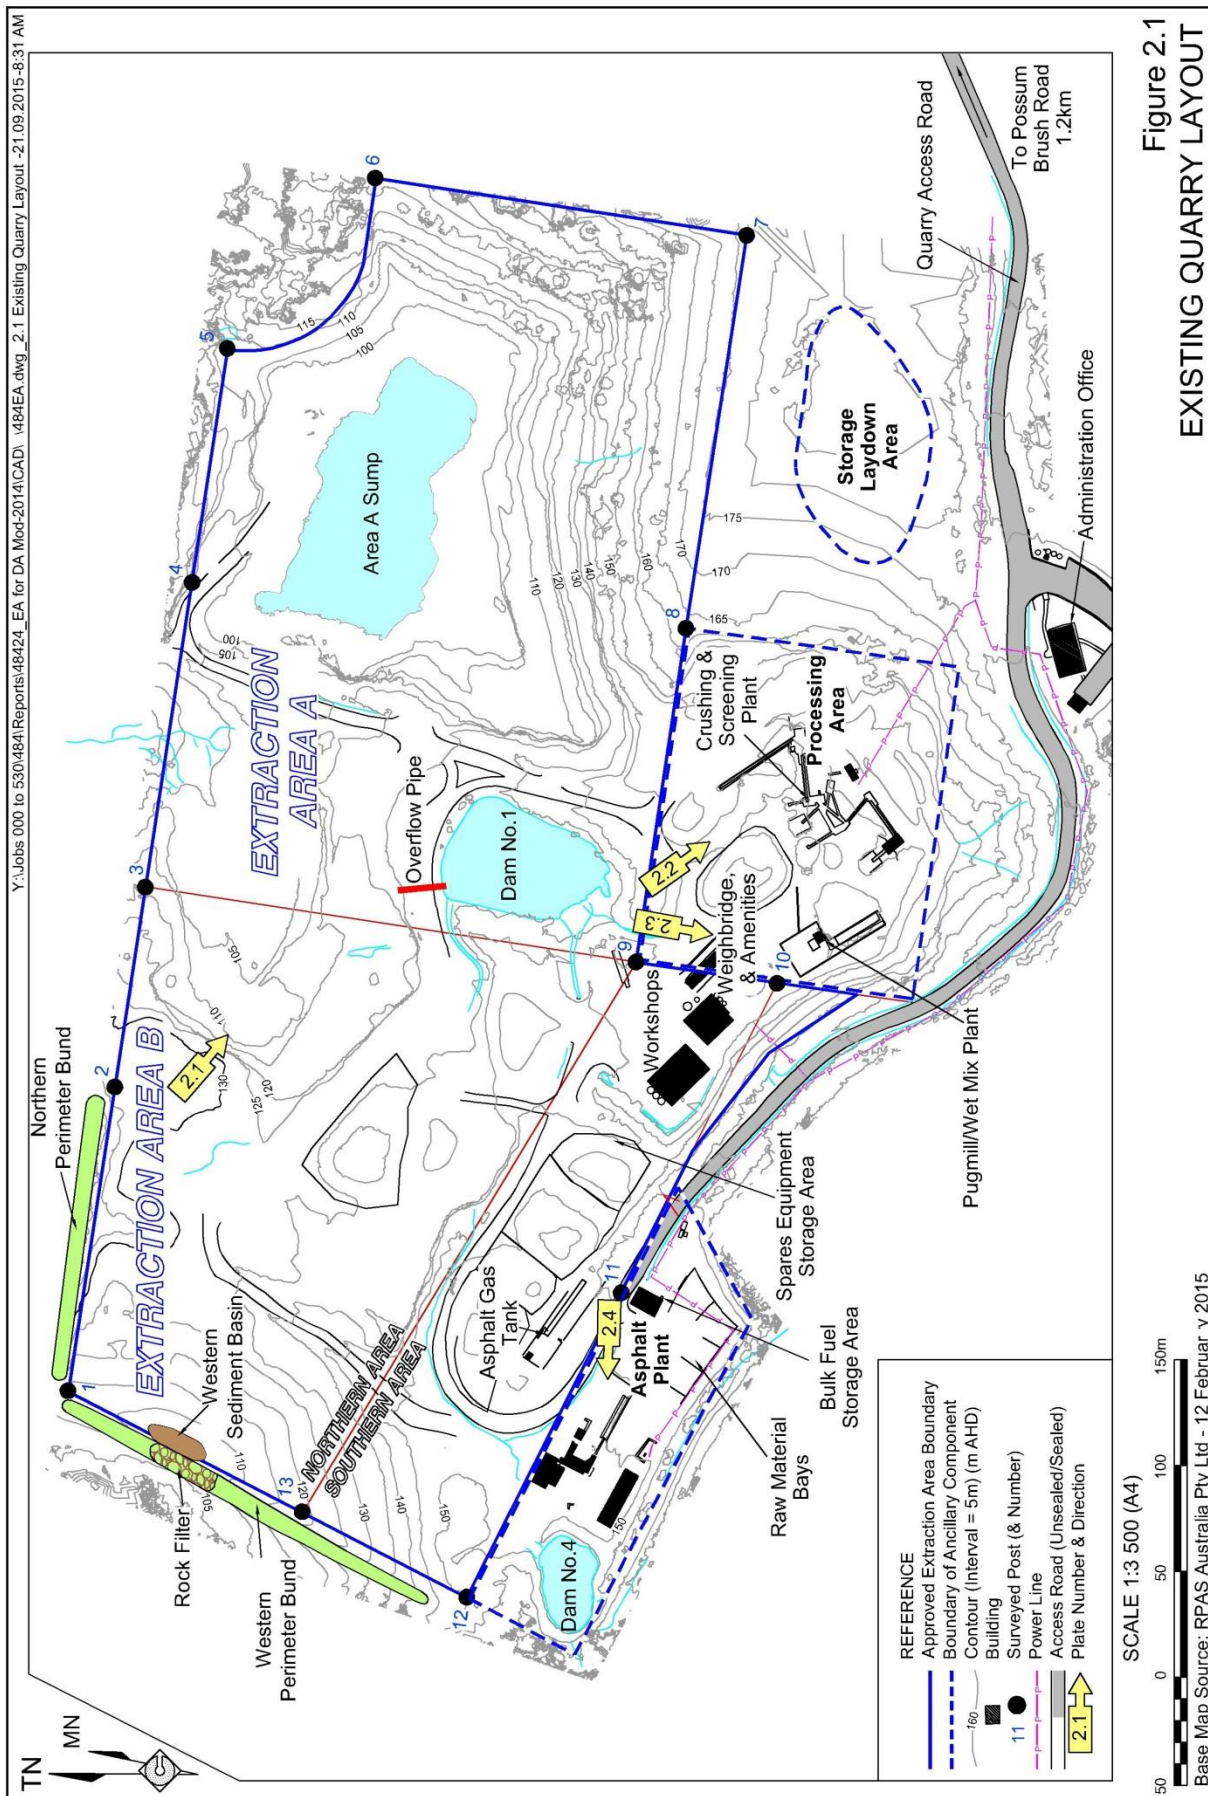
Figure 2.1
EXISTING QUARRY LAYOUT

PBM has continued to provide its high quality products from the Quarry to a number of construction projects including a range of projects involved with the Pacific Highway upgrade program and a number of local customers. The on-site asphalt plant, which commenced production in December 2008, continues to service a range of local infrastructure projects. **Figure 2.1** displays the current layout of the Quarry and the location of the current activities. **Plates 2.1 to 2.4** display various activity areas within the Quarry.

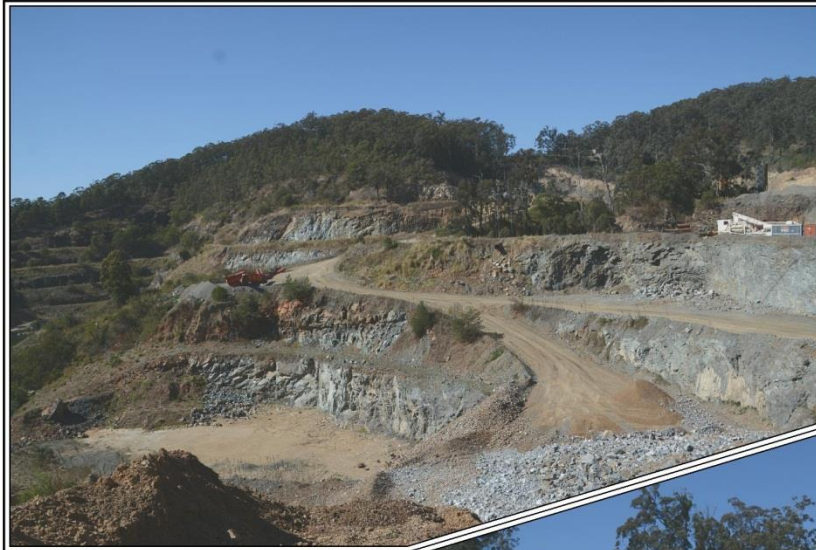
Plate 2.1: A view to the southwest across Extraction Area B
(Ref: E484M_019)

Extraction operations continue to be undertaken in both Extraction Areas A and B comprising a combination of select material/weathered rock and fresh rock. All extraction has been undertaken by either ripping with excavators and bulldozers or drill and blast followed by load and haul. Each blast typically generates between 15 000t and 35 000t of fragmented rock, with up to 15 blasts initiated in one year. Broken and fragmented rock suitable for processing is transported to the on-site processing plant by off-road haul trucks. All oversize rock is either sold as armour rock or transported to protected areas within Areas A and B for size reduction using a hydraulic hammer.

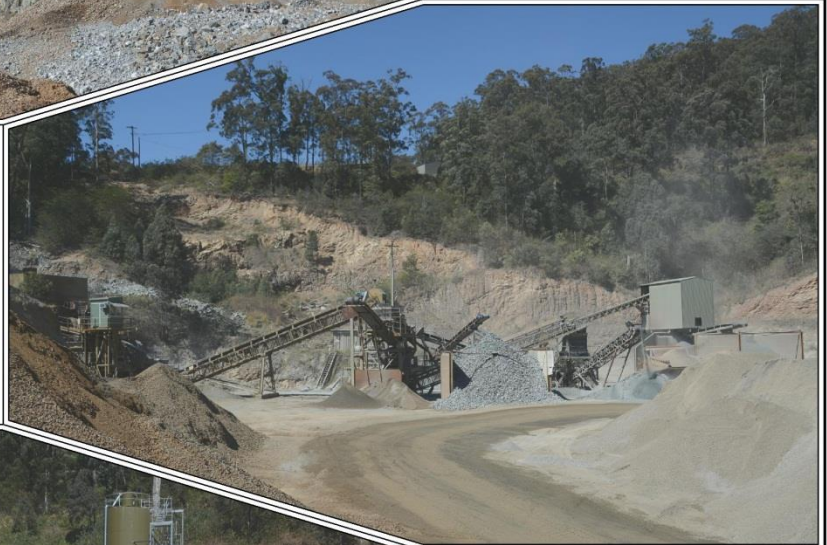
Plate 2.2: A view to the southwest towards the Processing Plant
(Ref: E484M_059)

Processing continues to be undertaken at the processing plant which incorporates crushing and screening machinery and a state-of-the-art pugmill, with processing generally taking place 6 days per week, typically starting at 6:30am and concluding at or before 6:00pm on a weekday and typically starting at 7:00am and concluding at or before 3:00pm on a Saturday, public holidays excluded.

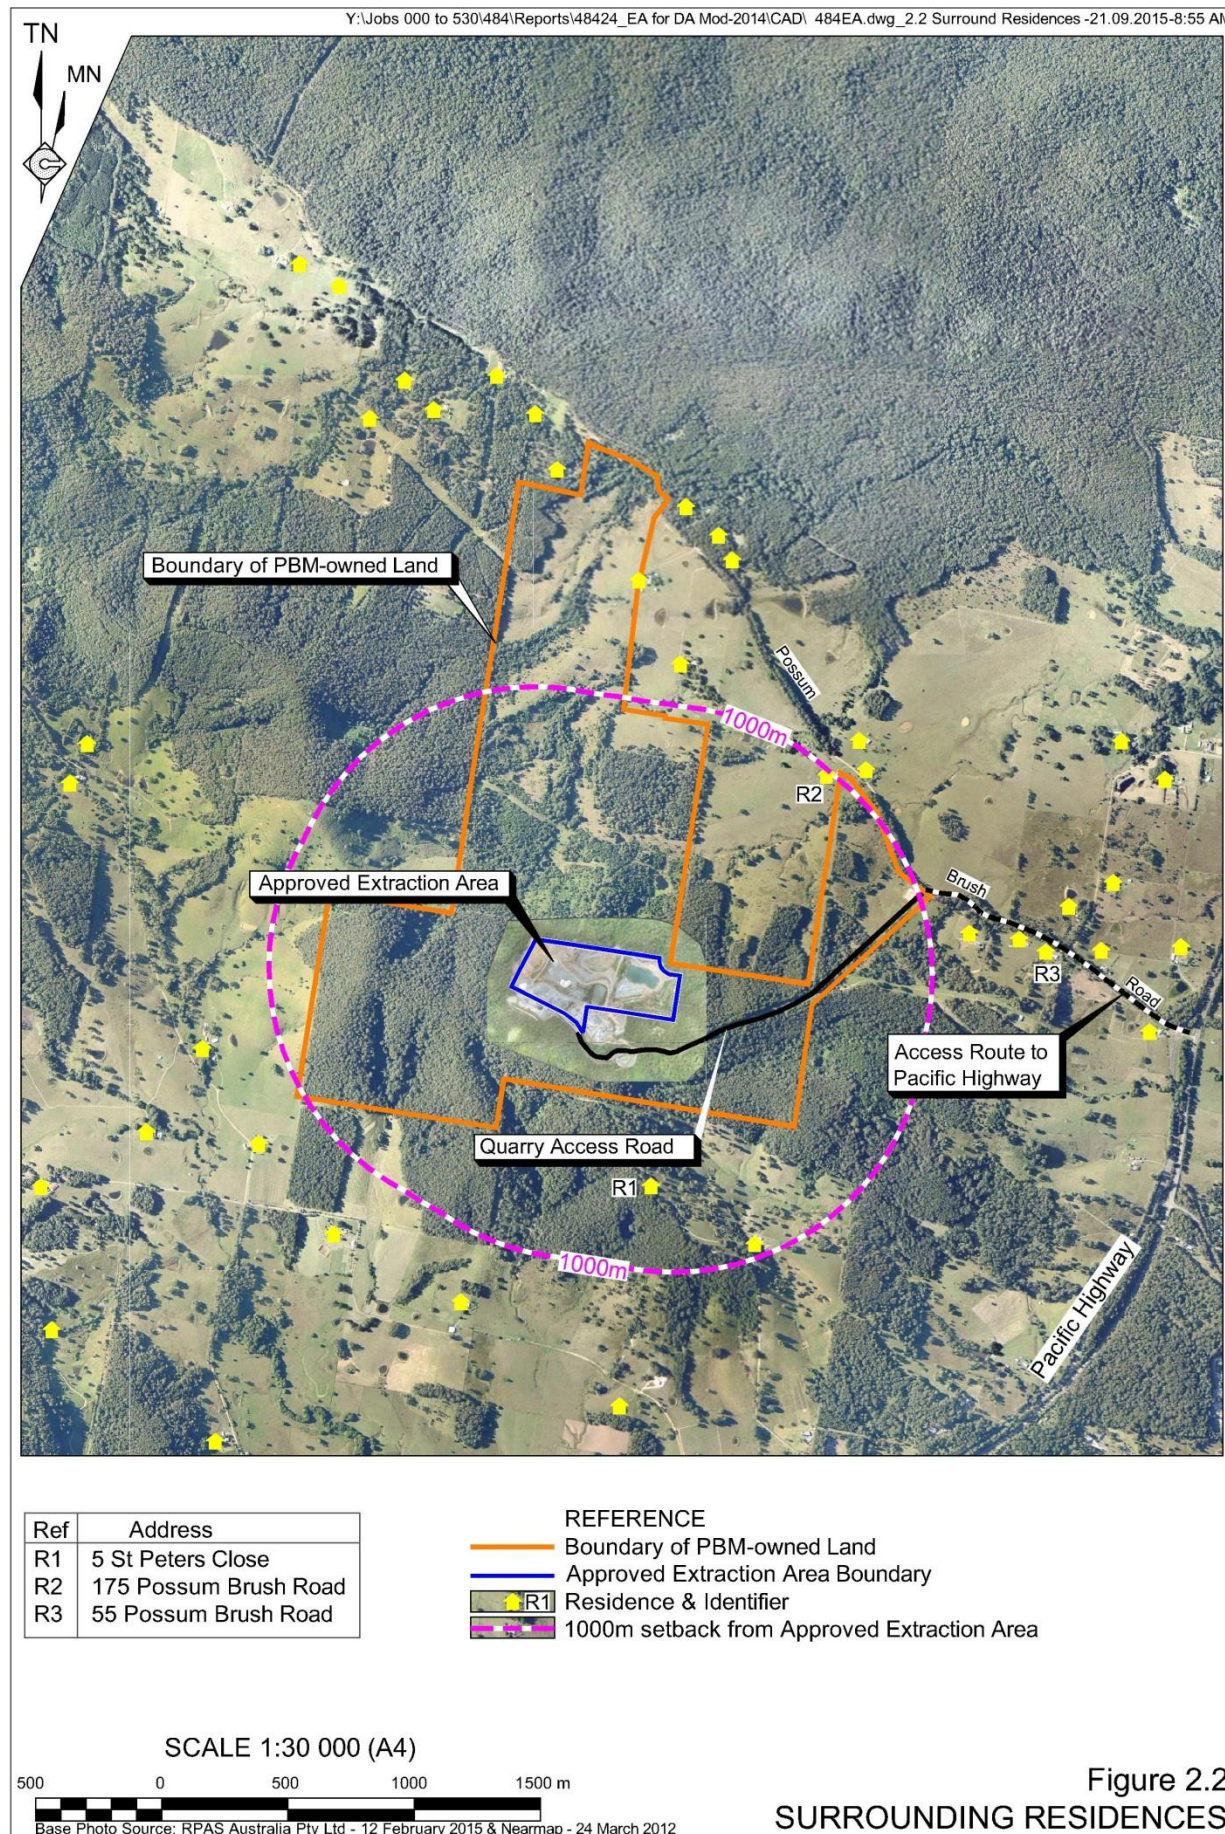
Figure 2.2 presents the land ownership surrounding the Quarry Site and the locations of residences on the surrounding agricultural land and rural lifestyle blocks, i.e. beyond a substantial vegetated buffer around the extraction areas. The Quarry has been intentionally located in an area that is well shielded both topographically and visually behind the substantial vegetation and at distances of greater than 1km to the residences to the east and northwest and approximately 0.5km from the closest residence to the south. It is noted that there is considerable topographic relief between the extraction areas and the various residences to the south and southeast.

The three residences at which noise monitoring is undertaken to establish compliance with Development Consent DA 283/87 and EPL 3393 conditions (see Section 2.3.2) are identified on **Figure 2.2. Table 2.1** identifies the owners of these three residences and their proximity to the extraction area.

Land adjacent to the active Quarry on the northern boundary is also owned by PBM with the following activities occurring within the identified areas (locations provided on **Figure 2.2**).

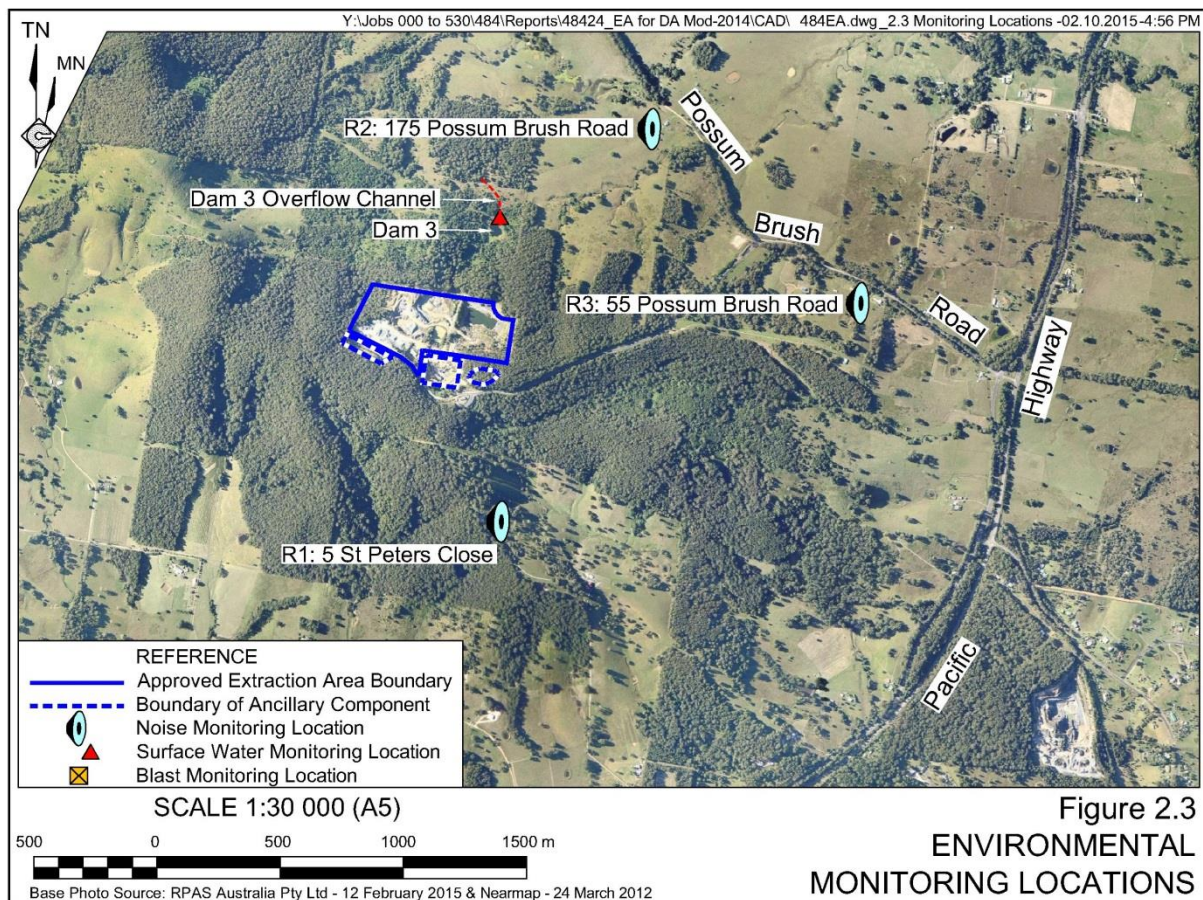
Figure 2.3
ENVIRONMENTAL
MONITORING LOCATIONS

Monitoring of noise is generally undertaken at the three locations displayed on **Figure 2.3** with **Table 2.2** providing the noise limits for each monitoring location as outlined within EPL 3393.
