Landscape and Rehabilitation Management Plan

Possum Brush Quarry

DA 283/97

October 2023

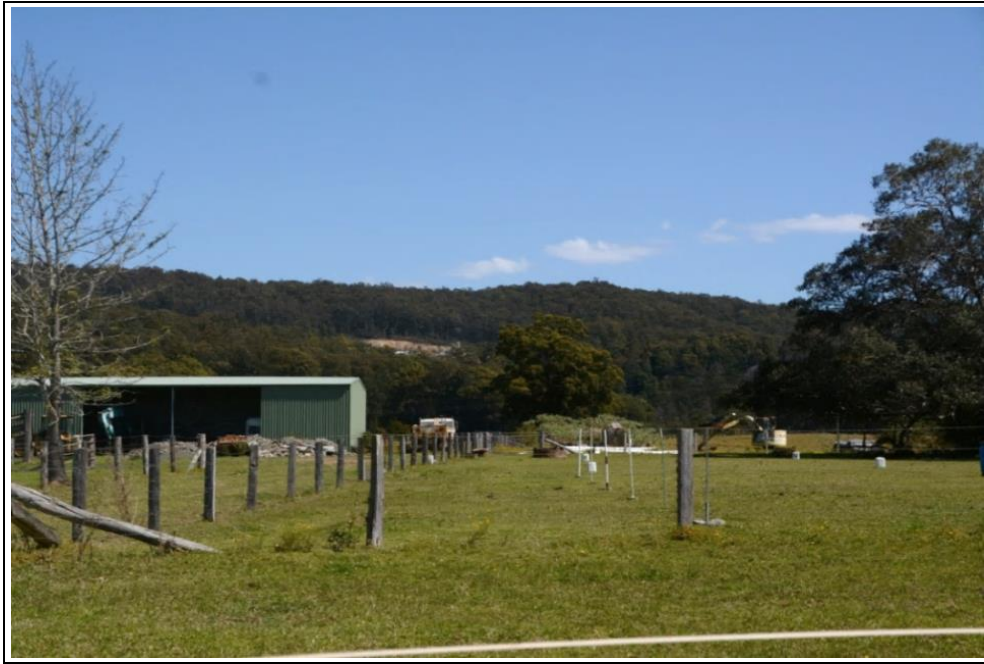
Plate 1 View to the southwest towards Possum Brush Quarry from Possum Brush Road

The only area where visibility is possible (due to the surrounding ridges and remnant vegetation) is from the northeast. **Plate 1** displays the view from Possum Brush Road near Residence 2 (see **Figure 3**). It is noted that the only areas of the Quarry that are visible from Possum Brush Road are the extracted slopes above the asphalt plant. The white LPG tank adjacent to the asphalt plant is visible from a short section of the Pacific Highway.

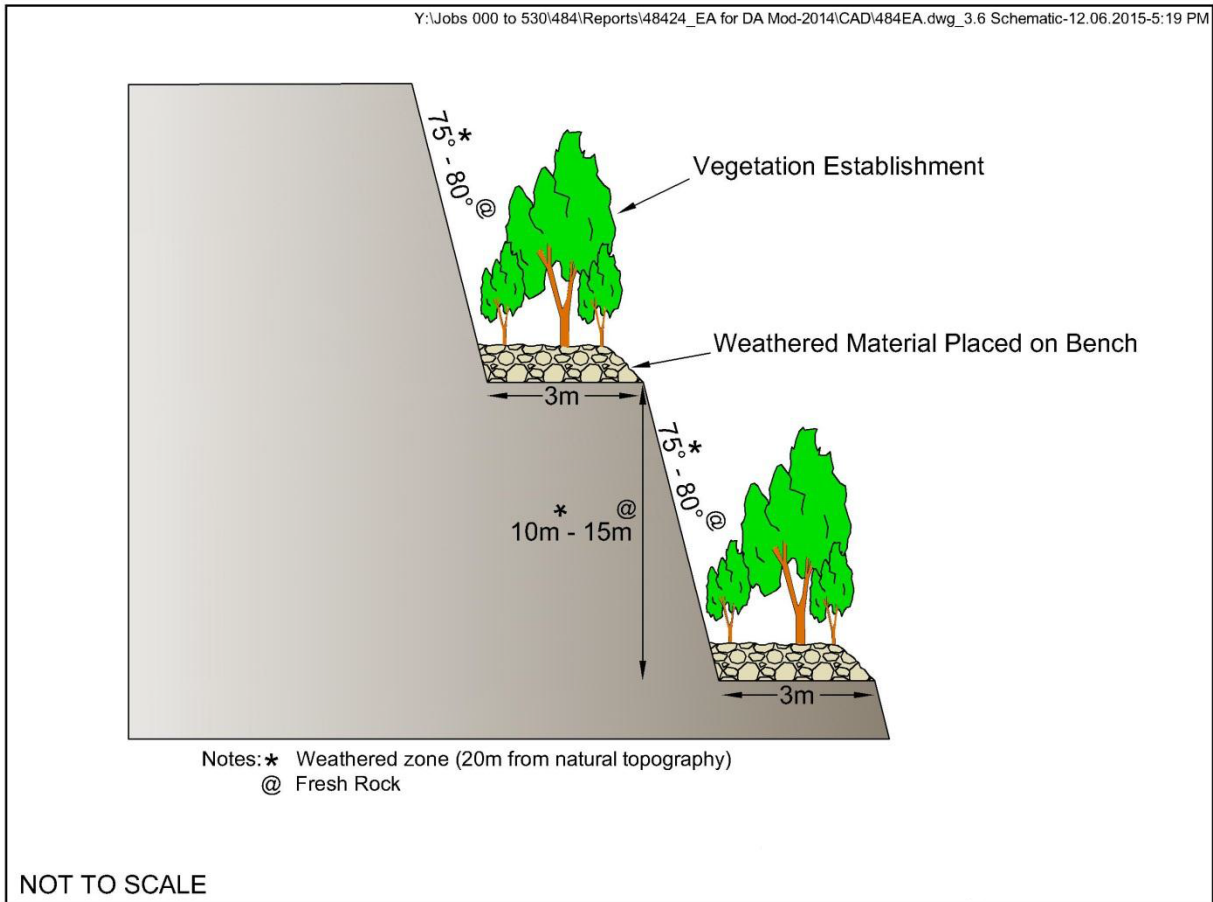
Figure 6 Schematic Rehabilitated Final Quarry Bench

- i) the placement of sufficient (approximately 1-2m) weathered overburden, with emphasis placed in creating a roughened surface to locally contain rainfall;
- ii) subsoil and topsoil (if available) will be placed on the overburden material generally to a depth of approximately 0.1- 0.15m. Soil will be preferentially be transferred from areas stripped of topsoil, however, where necessary, soil will be transferred from stockpiles;
- iii) the reliance upon natural regeneration on the substrate on each bench, similar to that which has already occurred on some of the eastern benches (see **Plate 2**);
- iv) depending on the source of the topsoil, a weed spraying program will be undertaken if required, to ensure weed growth is controlled early; and,
- v) supplementary planting of tubestock propagated with seed collected within PBM's property and will invariably include some of the following.

The final landform at the end of the Quarry life (**Figure 4**) displays the locations of the terminal benches. It is noted that a number of the final benches displayed in **Figure 4** would be generated beyond Stage 2, i.e. following a further modification of Development Consent DA 283/97. The benches completed during Stage 2 on the western, northern and eastern sides of the extraction area would be revegetated progressively throughout Stage 2. **Figure 5** provides a schematic of the rehabilitated final benches.
