Annual Review 2018-2019

Possum Brush Quarry

September 2019

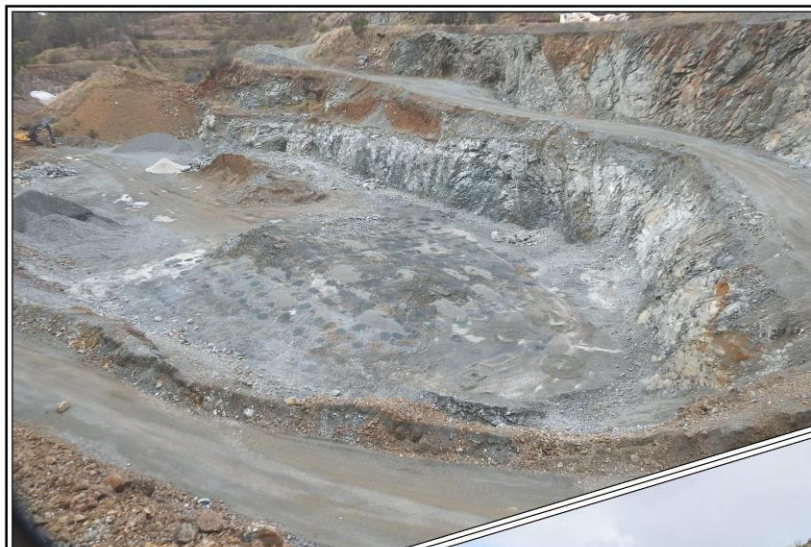
Plate 1: View to the east across
Extraction Area B
(Ref: E484Q_057)

All extraction throughout the reporting period was undertaken by either ripping with excavators and bulldozers or drill and blast followed by load and haul. **Plates 1 to 3** show the main extraction areas within Areas A and B of the Quarry.

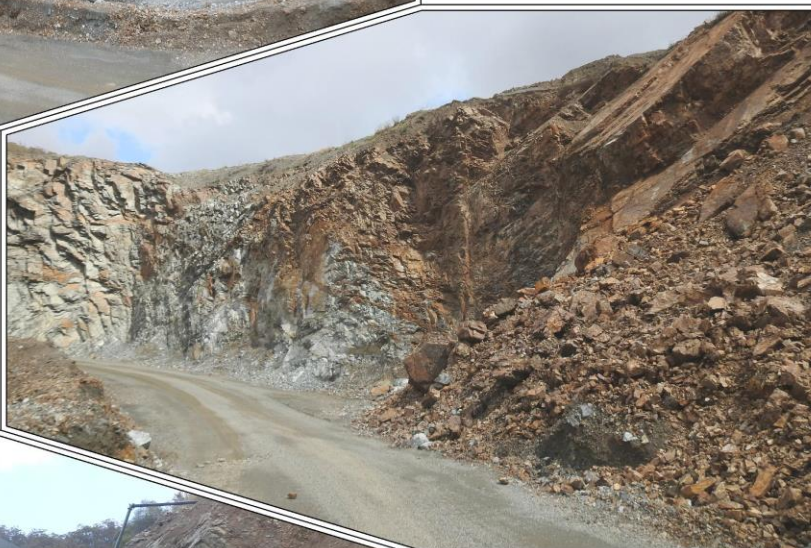
Plate 2: View to the southwest along
the Haul Road in Extraction Area B
Quarry (Ref: E484Q_027)

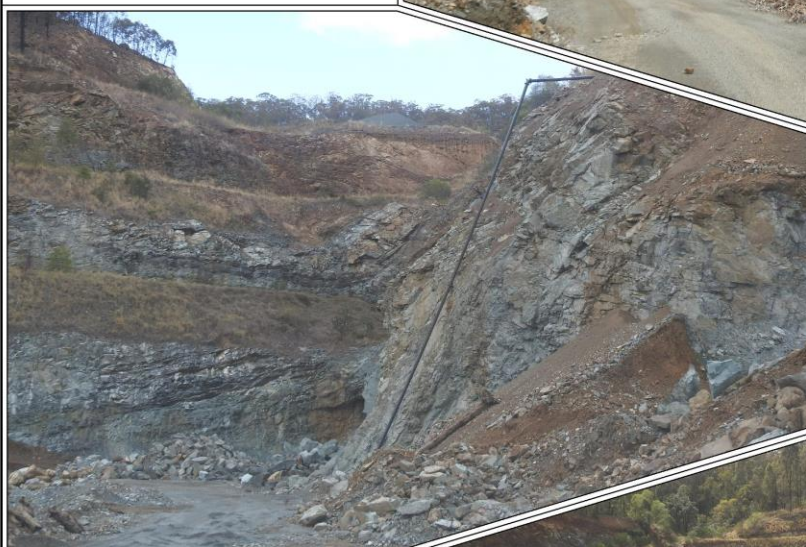
Plate 3: View to the south towards
the new constructed pipeline from
Area A Sump to Dam No.1
(Ref: E484Q_030)

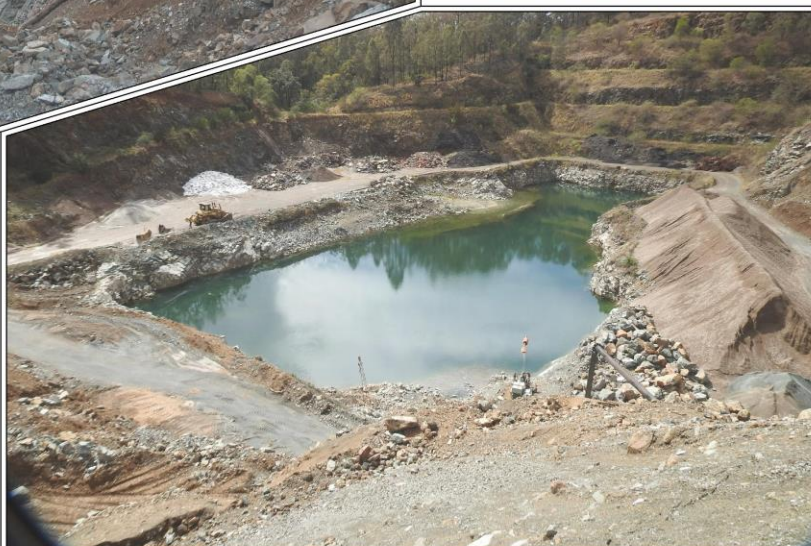
Plate 4: View to the east-northeast
across the Area A sump and
stockpile of <40mm crushed recycled
concrete (right hand side)
(Ref: E484Q_016)

Plate 11 displays the waste concrete and brick stockpiled on site awaiting processing. During the reporting period, a total of 7188.48 tonnes of waste materials were received for processing, the bulk of which was clean concrete. A high quality <40mm recycled concrete product was produced during the reporting period (see **Plate 4**)

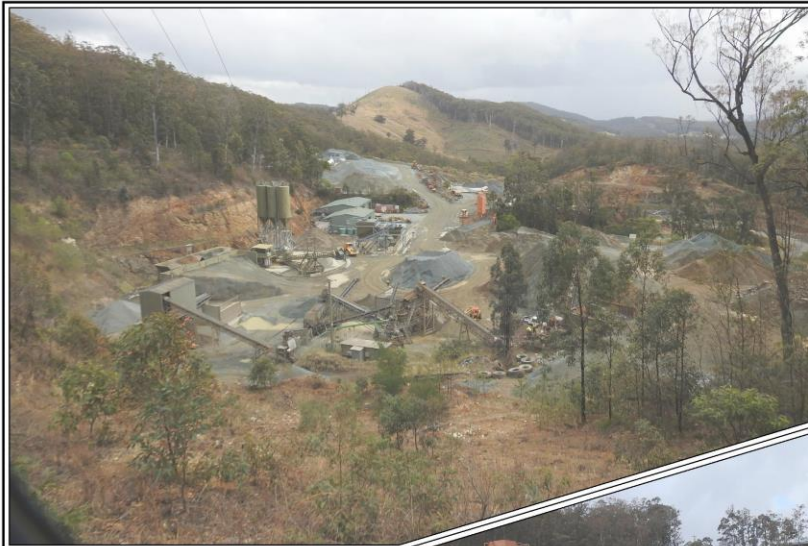
Plate 5: View to the northwest
 across the processing plant
 (Ref: E484Q_062)

The bulk of the fragmented rock was processed on site through the processing plant (see **Plate 5**) with the bulk of the products being produced within the state-of-the-art pugmill/wetmix plant.

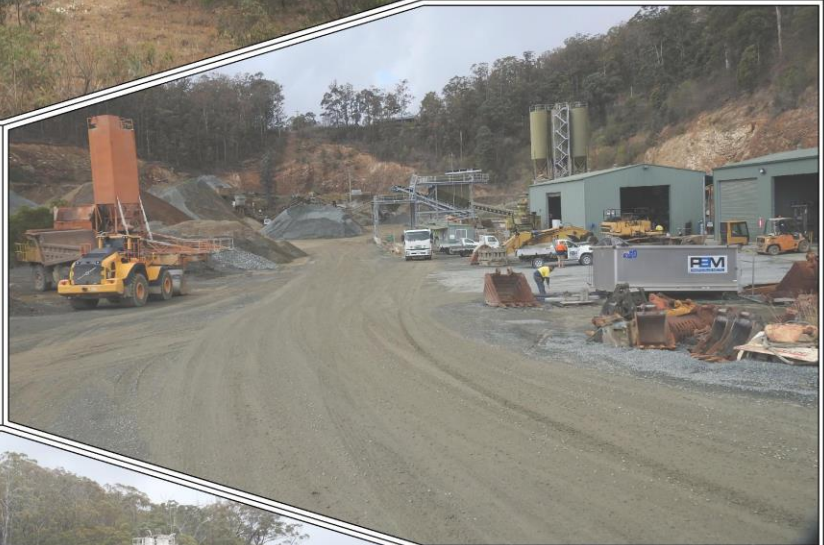
Plate 6: View to the southeast
 across the floor of the processing
 plant and related buildings
 (Ref: E484Q_001)

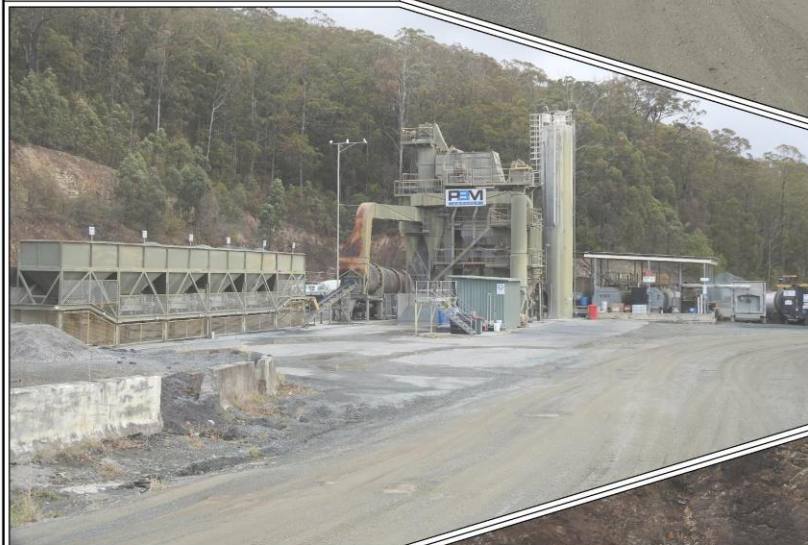
Plate 7: View to the west towards
 the Asphalt plant
 (Ref: E484Q_059)

In accordance with *Condition 10* DA1127/205 and *Condition L6.2 (h-i)* EPL 3393, the asphalt plant is approved to operate during the standard hours of operation for the Quarry and 24 hours per day from 6:30am Monday to 10:00pm Friday for up to 60 days per year to supply asphalt to community infrastructure projects requiring night-time deliveries of asphalt, a condition that was met throughout the reporting period. Plate 7 presents a view to the west towards the asphalt plant.

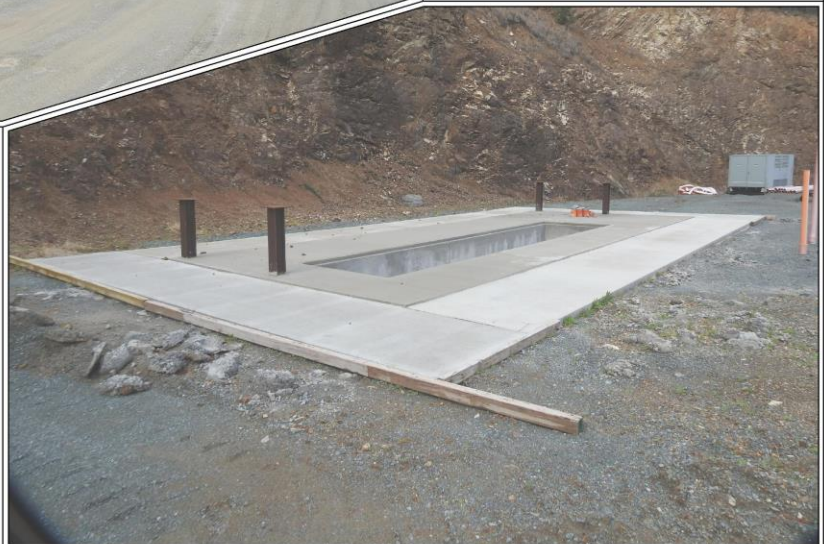
Plate 8: View to the south across the
 concrete pad foundation for the
 proposed new switch room
 (Ref: E484Q_012)

The progressive upgrade of the electrical substation and switch room will also continue to be undertaken throughout the 2019-2020 reporting period.

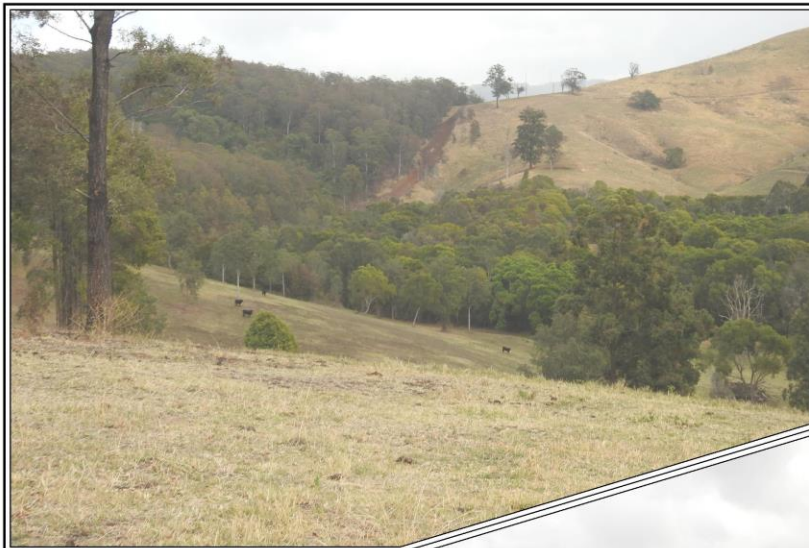
Plate 9: View to the west towards the wildlife corridor from the elevated ridge east of the corridor (Ref: E484Q_043)

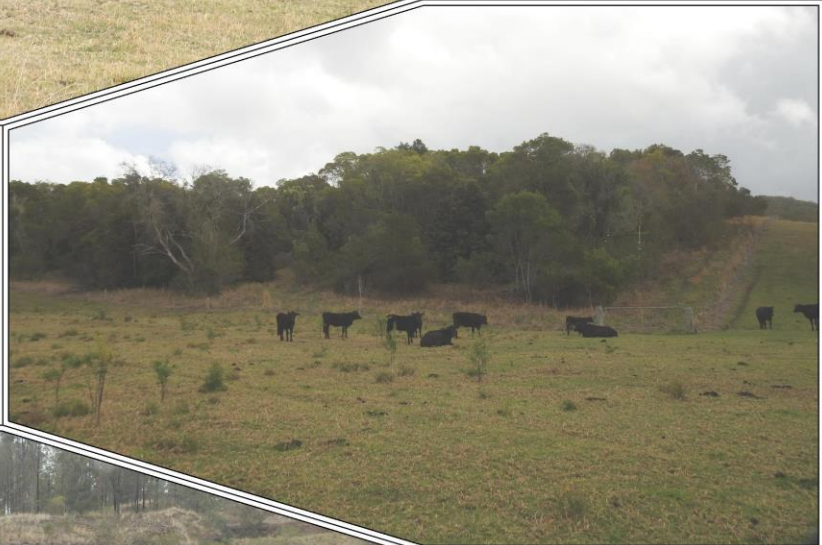
Plate 10: View to the west towards the wildlife corridor from the adjoining low land (Ref: E484Q_047)

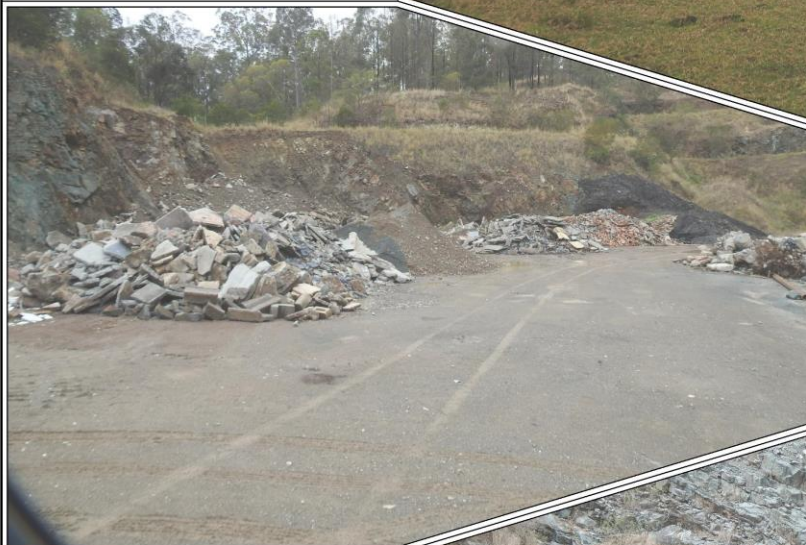
Plate 11: View to the east across the incoming waste stockpiles (Ref: E484Q_036)

In accordance with *Condition L3.2* EPL 3393, the authorised amount of waste brought into the Quarry must not exceed 10 000 tonnes per year i.e. for the year ending on the anniversary date of 17 August. In October 2018, PBM exceeded this authorised amount by 376 tonnes. PBM self-reported the exceedance to EPA and the EPA issued a Show Cause letter. No further action was taken. PBM provided monthly Waste and Resource Reports to EPA detailing the tonnage of recycled products received, processed and despatched.

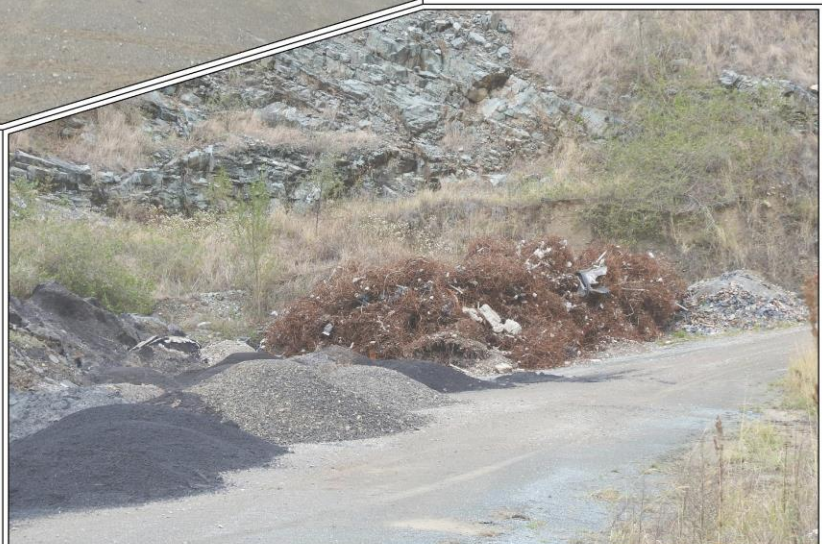
Plate 12: View to the south towards the steel stockpile recovered from recycled concrete (Ref: E484Q_034)
