Annual Review 2016-2017

Possum Brush Quarry

Pacific Blue Metal Pty Ltd
ABN: 45 050 224 250
Possum Brush Rd
POSSUM BRUSH NSW 2430

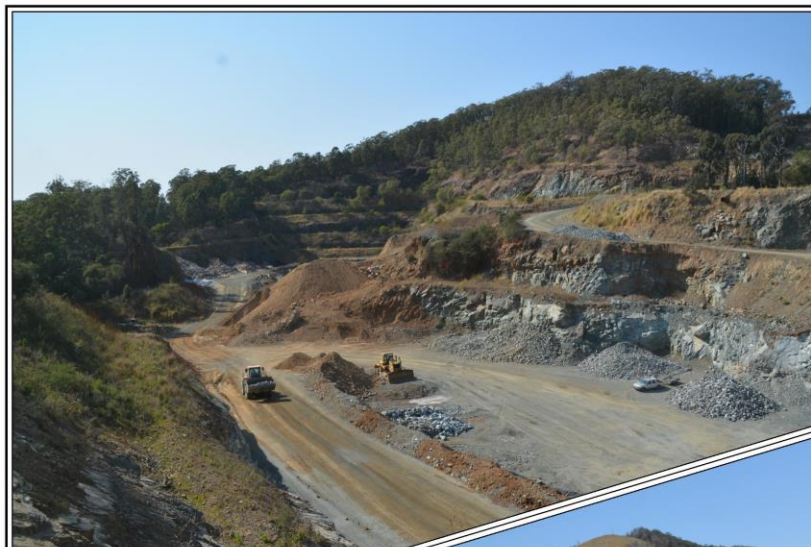
Plate 1: View to the east from part of
Extraction Area B
(Note: Area A in background)
(Ref: E484O_033)

All extraction throughout the reporting period was undertaken by either ripping with excavators and bulldozers or drill and blast followed by load and haul. **Plates 1 to 4** show the status of the various extraction areas within the Quarry.

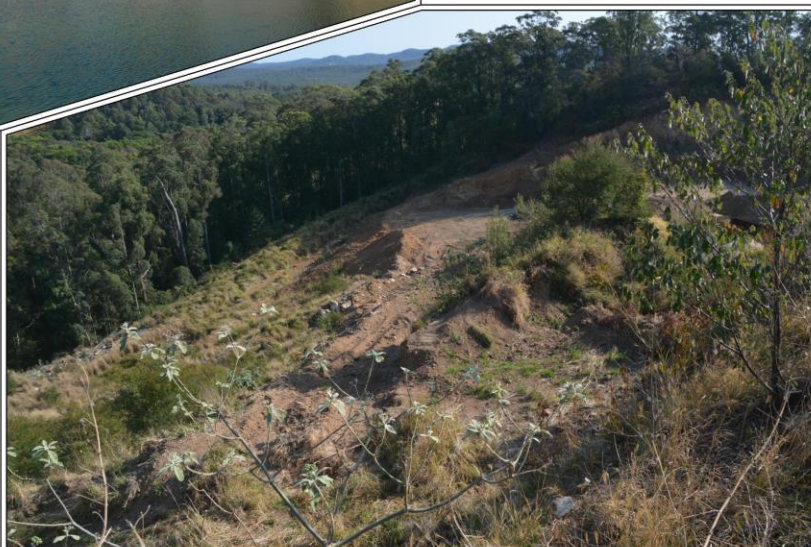
Plate 4: Area extracted for
weathered material in the western
side of Area B
(Ref: E484O_002)

1. A 0.4ha area on the western side of Area B where weathered rock was removed to a depth of approximately 115m AHD.
2. A 0.9ha area on the northern side of Area B, where predominantly fresh rock was extracted from 130m AHD to 105m AHD benches.
3. A 0.1ha area between locations 1 and 2 where weathered rock was removed; and
4. A 0.2ha area near the southern side of Area A between 120m and 100m AHD.

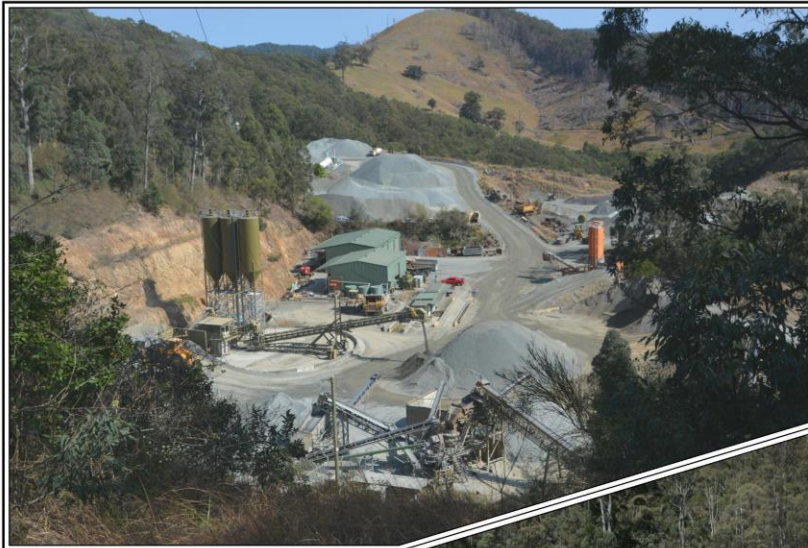
Plate 5: View to the north across the Processing Plant and stockpiles
 (Ref: E484O_066)

The bulk of the fragmented rock was processed on site through the processing plant (see **Plate 5**) with the bulk of the products being produced within the state-of-the-art pugmill/wetmix plant (see **Plate 6**).

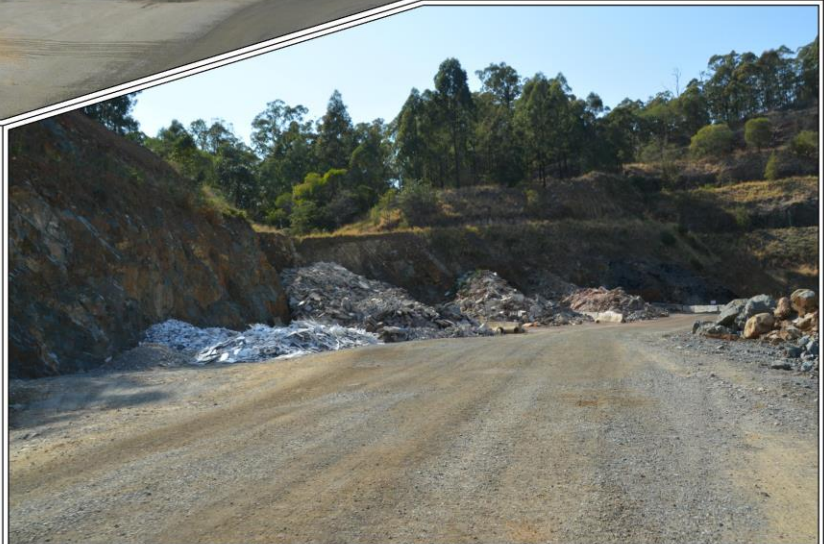
Plate 8: Waste storage bays in Extraction Area A
 (Ref: E484O_041)

During the reporting period, PBM continued to receive concrete and other waste materials suitable for reprocessing and blending with other quarry products. **Figure 2.2** displays the location of the recycled material receival bays within Extraction Area A (see **Plate 8**). The wastes received comprised:

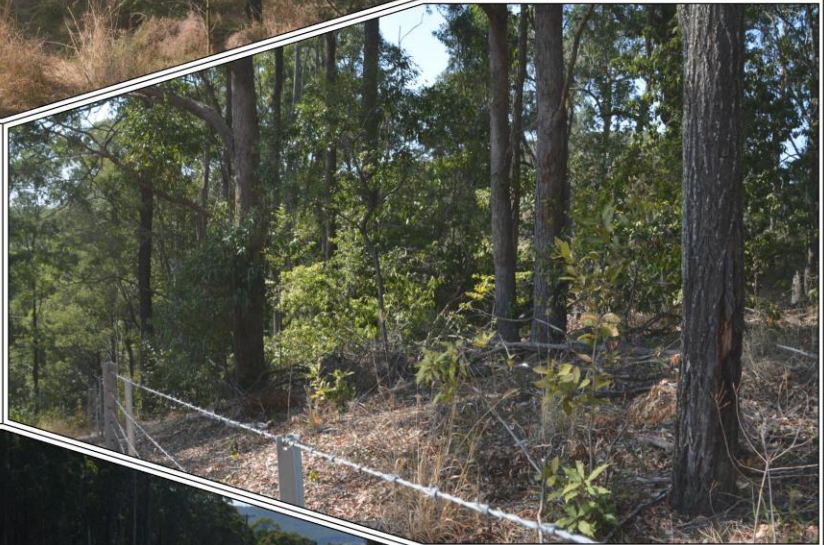
Plate 10: 50m Buffer Zone on
northern side of Quarry
(Ref: E484O_028)

Primary and secondary weeding continued within the buffer zone during the reporting period. The densities of the two major weeds within the buffer zone, Lantana and White Passionfruit, were further reduced within the buffer zone during the reporting period.

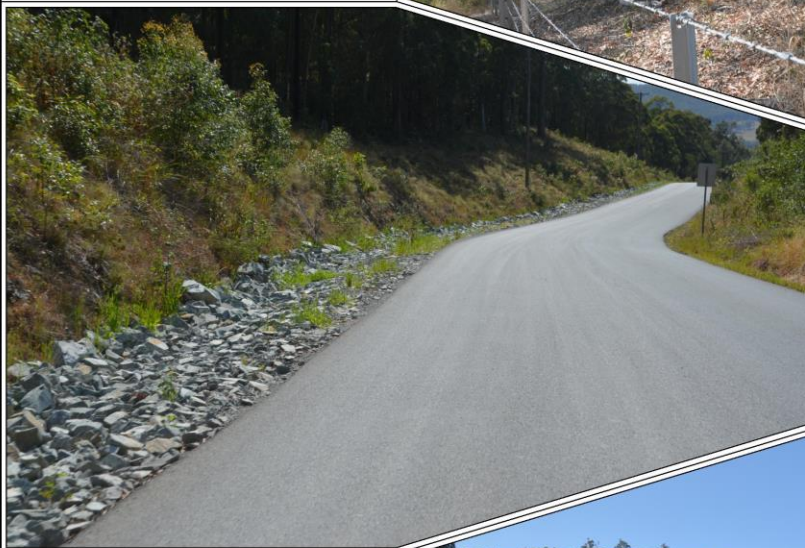
Plate 11: Scour protection material
placed adjacent to Access Road
(Ref: E484O_068)

No maintenance of the road pavement surface within the Quarry Site or along the access road was required given it has been surfaced with asphalt. PBM upgraded the roadside drainage in the area displayed on **Figure 2.1**, principally through the placement of suitably sized scour protection material (see **Plate 11**).

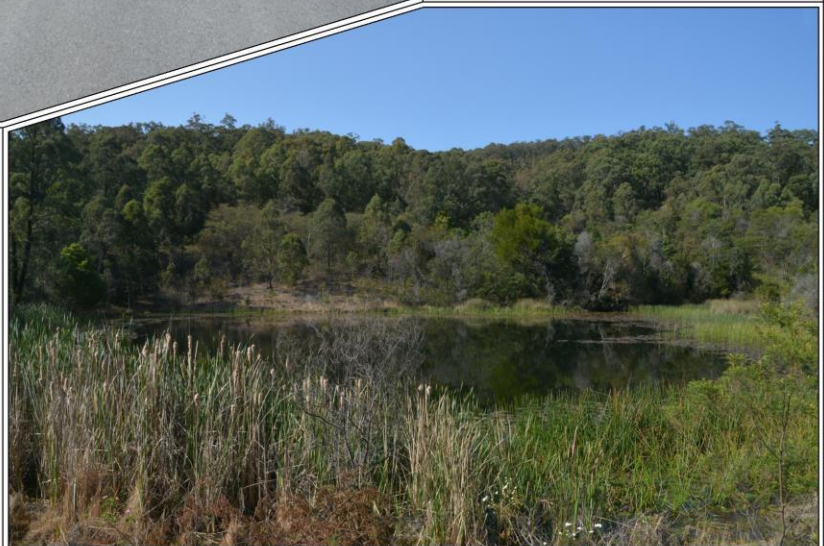
Plate 12: Dam 3
(Ref: E484O_026)

The PBM Water Monitoring point is located at the overflow of Dam 3 (see **Figure 2.1**). Monitoring is required at this point when an overflow event occurs as per EPL 3393 *Condition M2*. EPL 3393 *Condition L2.5* stipulates the Water concentration limits for pollutants at the overflow, these being:

Water quality monitoring was undertaken on two (2) occasions during the reporting period, namely 03/08/16 and 15/03/17. There was no visible oil and grease observed at either time of sampling. Both pH and TSS levels were within the limits nominated in EPL 3393, the pH range was 7.0-7.1 and TSS range was 7.1-19mg/L
