Annual Review 2021-2022

Possum Brush Quarry

September 2022

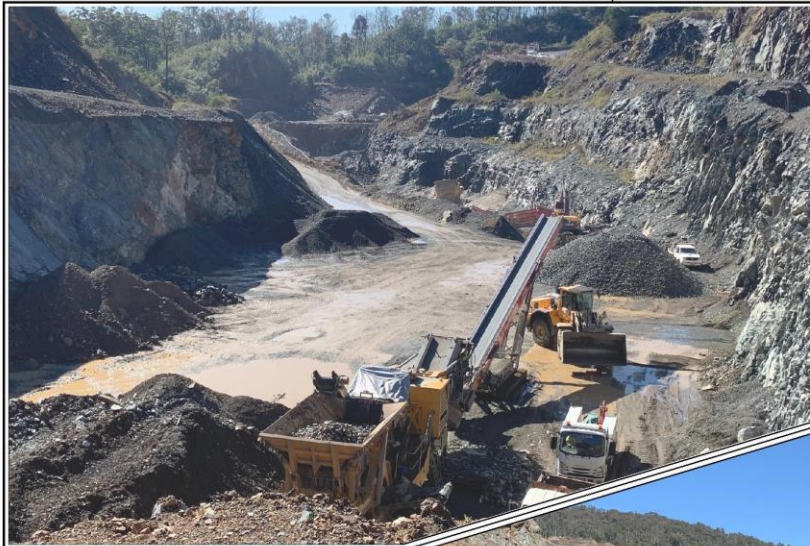
Plate 1: View to the east of the active extraction area

All extraction throughout the reporting period was undertaken by either ripping with excavators and bulldozers or drill and blast followed by load and haul. **Plates 1** and **2** show the main extraction area of Area B.

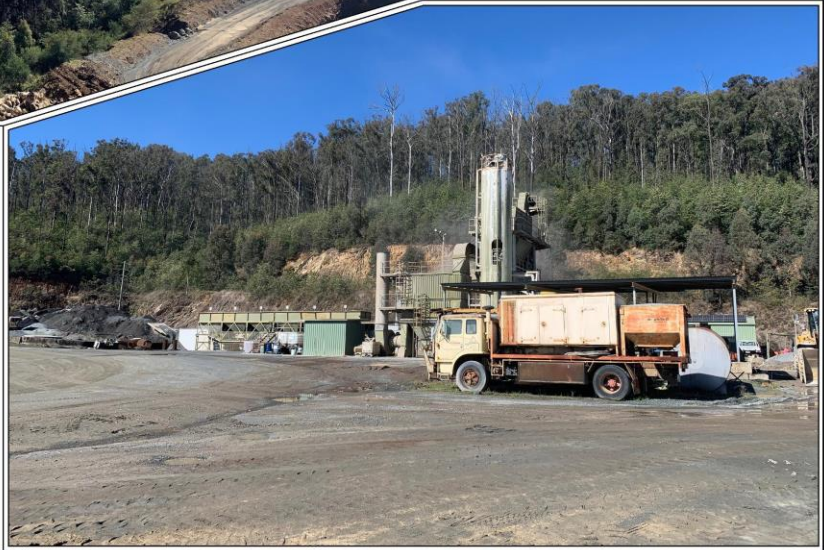
Plate 9: View to the southeast towards the Asphalt Plant

Whilst the asphalt plant is approved to operate during the standard hours of operation for the Quarry, as permitted under *Condition 10* DA 1127/2005 and *Condition L6.2* (h-i) EPL 3393, PBM may operate the asphalt plant for 24 hours per day, from 6:30am Monday to 10:00pm Friday, for up to 60 days per year. This is so that PBM may supply asphalt to community infrastructure projects requiring night-time deliveries. **Plate 9** presents a view of the asphalt plant towards the south east.

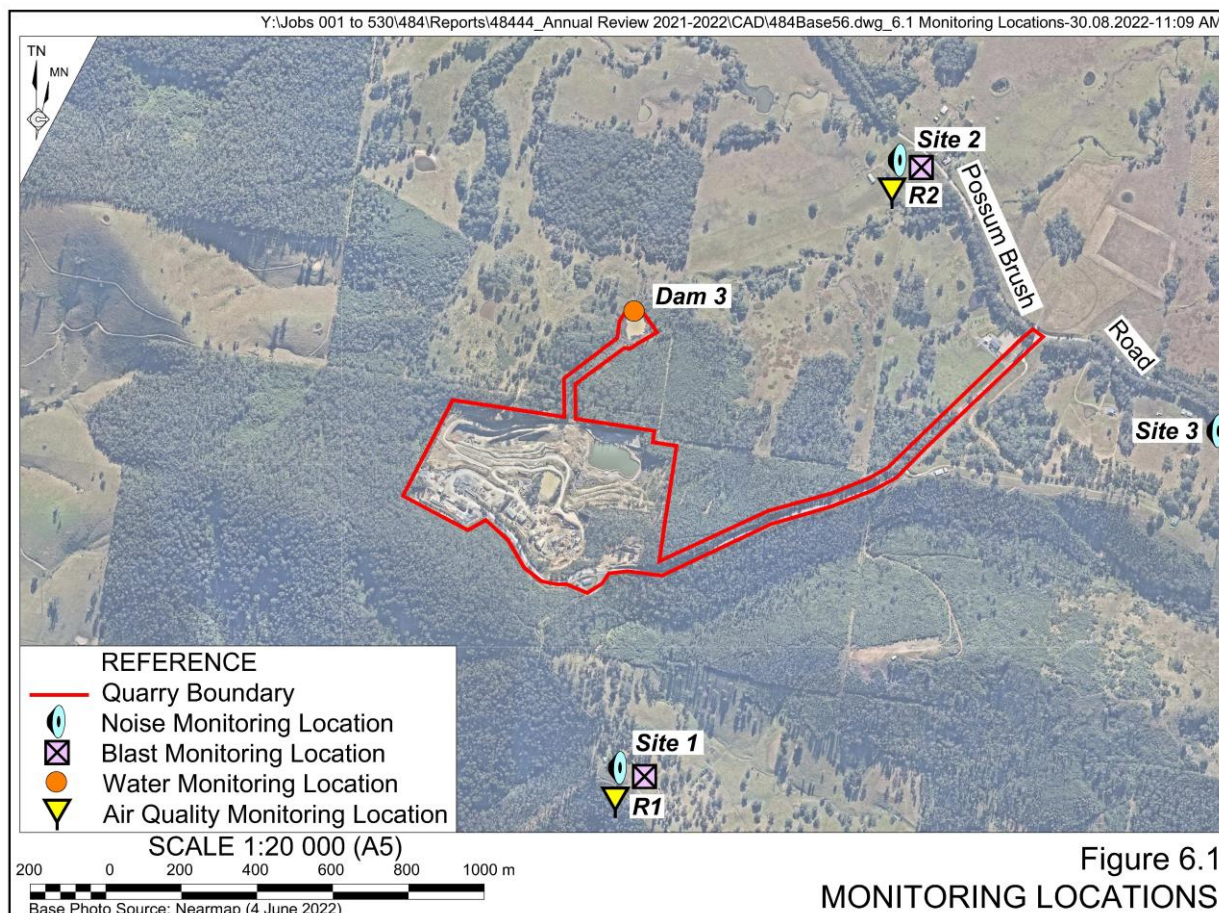
Table 5 presents the results from the noise monitoring undertaken during 2021-2022. Noise monitoring covering only the day period was undertaken on 17 December 2021 at the three nominated noise monitoring locations (see **Figure 6.1**).

- Site R1: 5 St Peters Close;
- Site R2: 175 Possum Brush Road; and
- Site R3: 55 Possum Brush Road.

A total of 12 blasts were initiated during the reporting period. All blasts were monitored at Site R1 (5 St Peters Close) and Site R2 (175 Possum Brush Road) (see **Figure 6.1**) and were all within the airblast overpressure and ground vibration criteria nominated within *Condition 3(4)* of DA 283/97 (Mod 4) and *Condition L5* of EPL 3393. As recorded in **Table 6**, airblast levels recorded at Site R1 ranged from Nil Trigger to 103.5dB(L) with recorded ground vibration levels varying from Nil Trigger to 2.83mm/s. Airblast levels recorded at Site R2 ranged from Nil Trigger to 102.8dB(L) with recorded ground vibration levels varying from Nil Trigger to 0.98mm/s, the majority of blasts did not trigger Site R2. Blast monitoring results for the reporting period remained consistent with historic results.
