Landscape and Rehabilitation Management Plan

Possum Brush Quarry

DA 283/97

December 2019

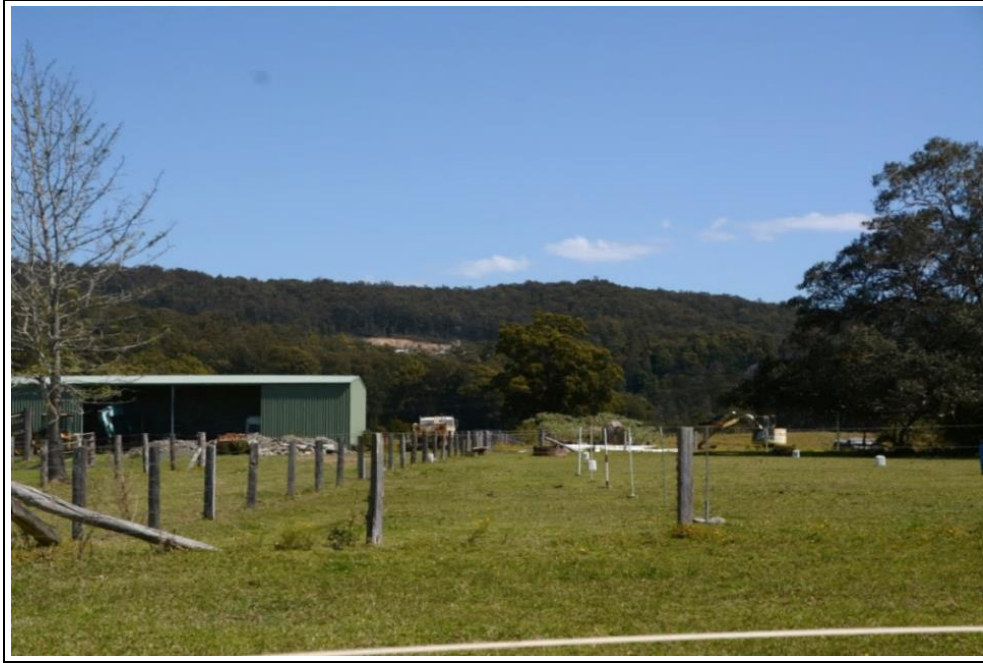
Plate 1 View to the southwest towards Possum Brush Quarry from Possum Brush Road

The only area where visibility is possible (due to the surrounding ridges and remnant vegetation) is from the northeast. **Plate 1** displays the view from Possum Brush Road near Residence 2 (see **Figure 3**). It is noted that the only areas of the Quarry that are visible from

Possum Brush Road are the extracted slopes above the asphalt plant. The white LPG tank adjacent to the asphalt plant is visible from a short section of the Pacific Highway.

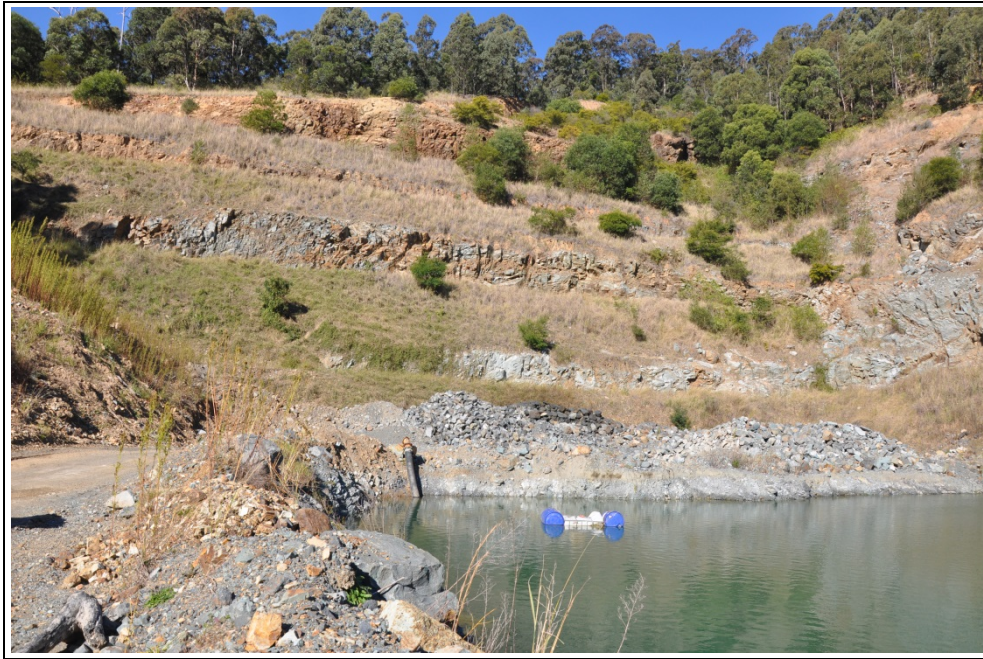
Plate 2 Natural revegetation on the eastern faces of Area A (Photo Ref. E484I_030)

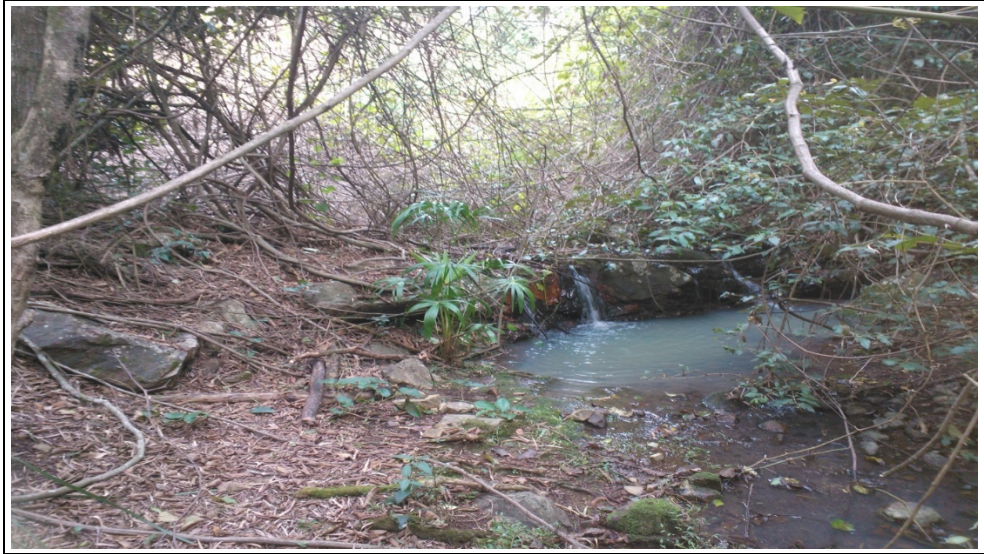
Plate 3 Creek in Wildlife Corridor after weed control and rain event

- adjacent to the quarry access road,
- a 50m wide corridor adjacent to the northern boundary of the approved extraction area
- within the wildlife corridor (see **Plate 3**)

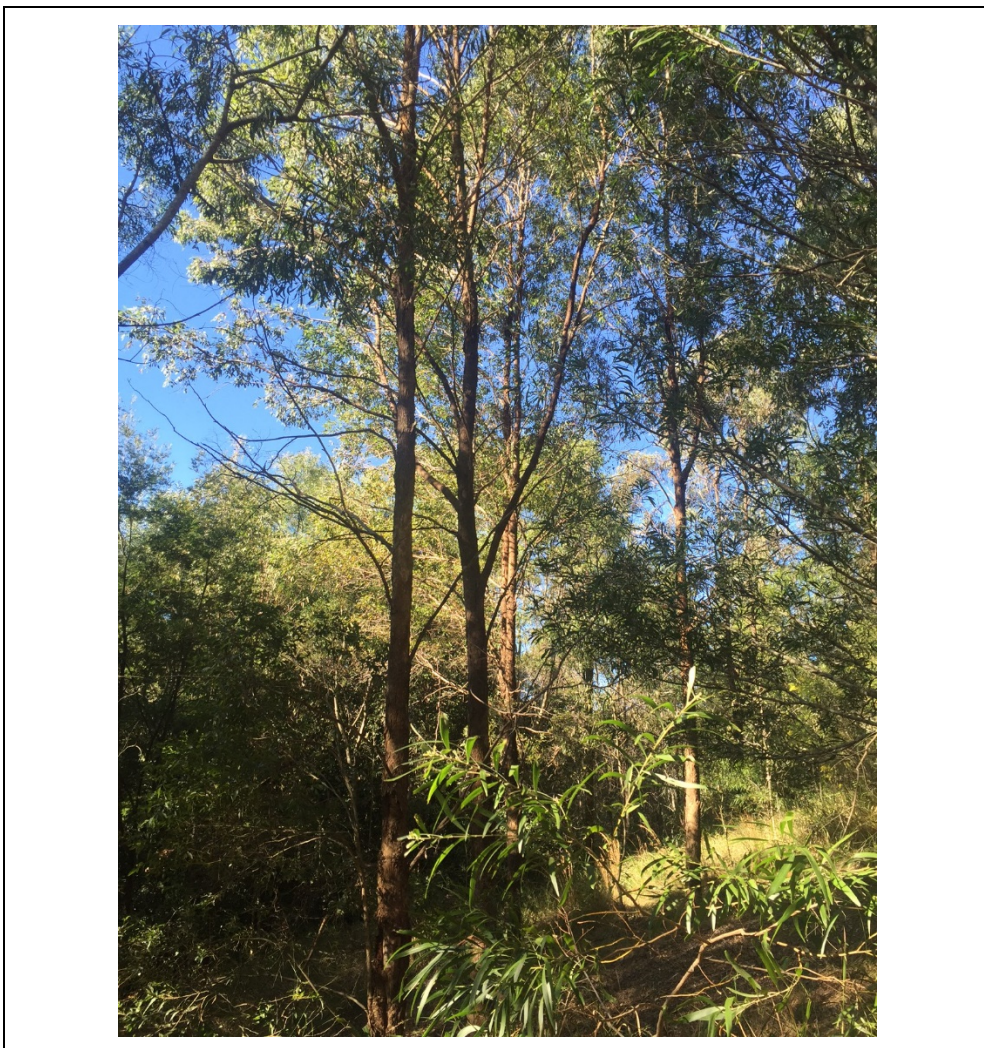
Plate 4 Planted Rudders Box in Wildlife Corridor
